Job #517836371

## HB Service/Maintenance Report (Furnace)

Maintenance Tune Up

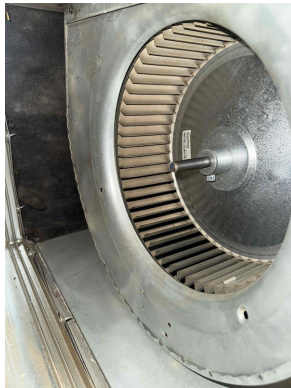
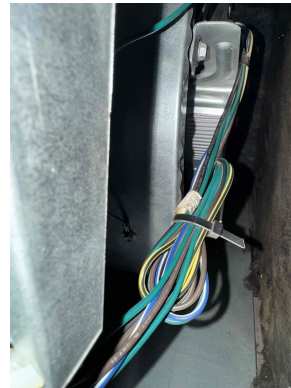
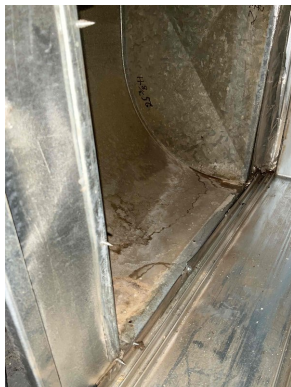
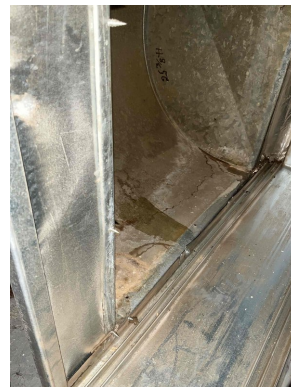
Blower wheel has light dust buildup on the fins. Blower motor has no loose connections or signs of oil leakage from the bearings. Ducts have dust buildup present in the return drop

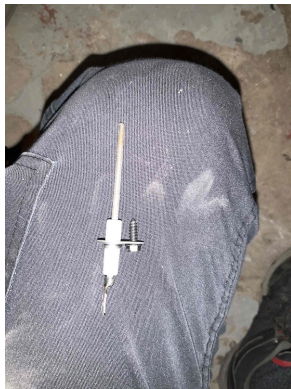
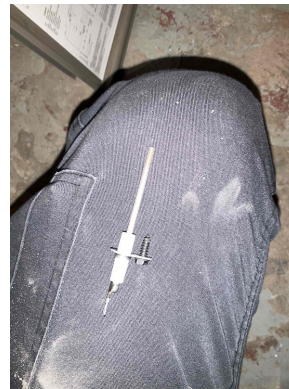
Flame sensor was reading within spec but has some carbon staining present on the flame rod - in better condition after cleaning . Ignitor is in good condition with minimal white discoloration on the ignition rod

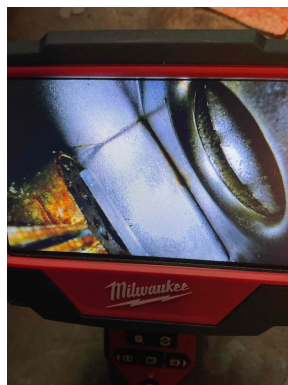
Burners are in good condition with minimal rust on the heads and carryover tracks

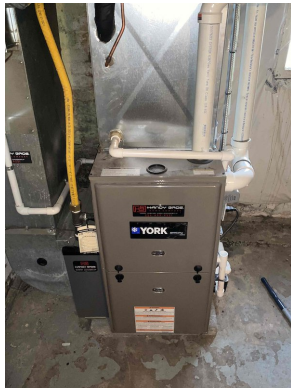
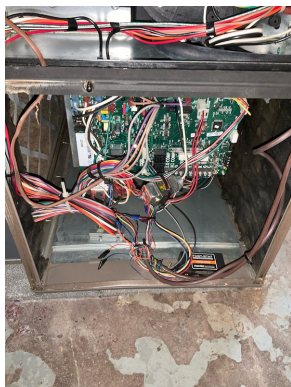
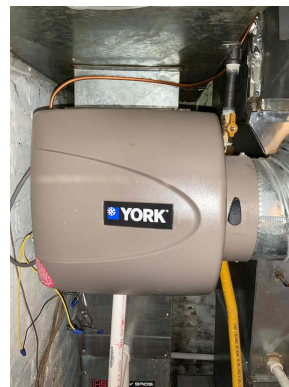
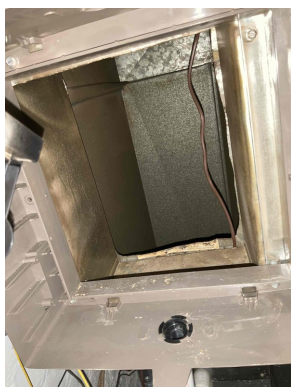
## Before Photos of Equipment Cleanings Today

Stand back and take a photo of the equipment compartments before maintenance.

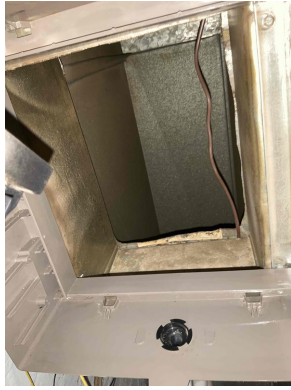
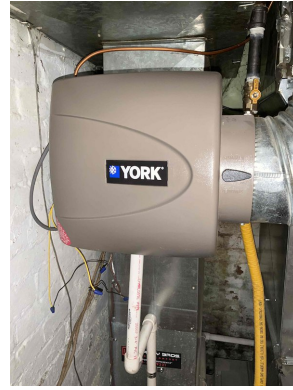
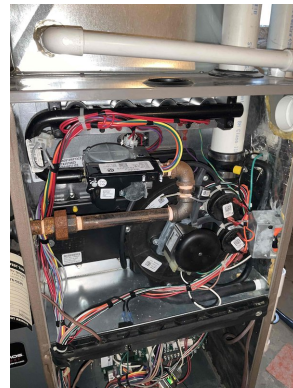
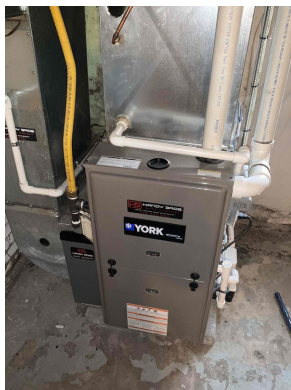
## After Photos of Equipment Cleanings Today

Stand back and take a photo of the equipment compartments after maintenance.

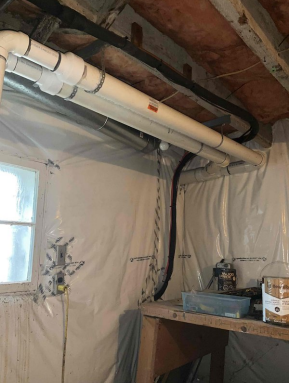
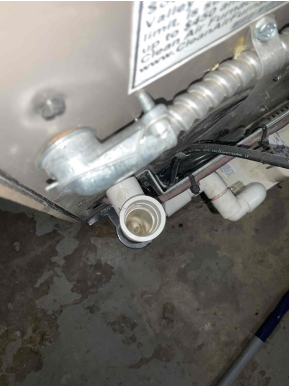
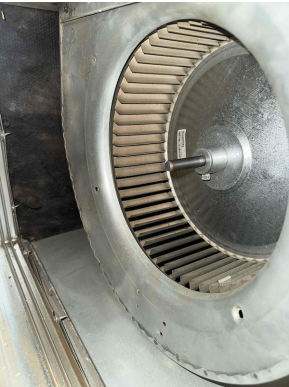
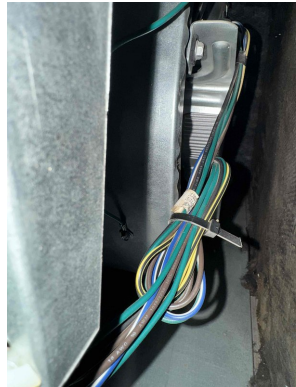
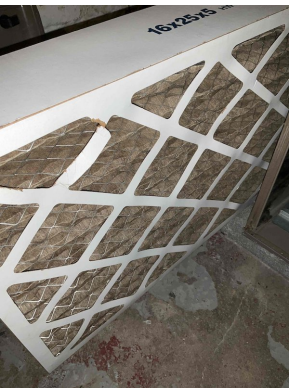
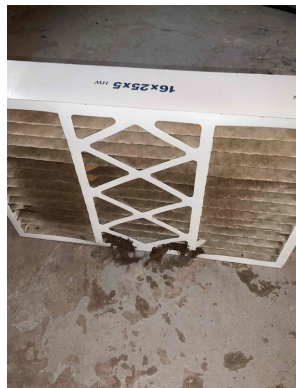
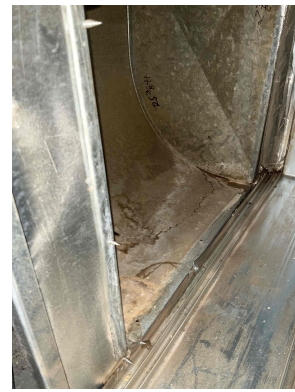
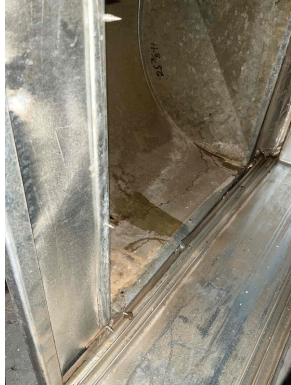
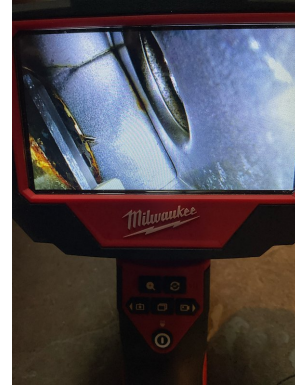
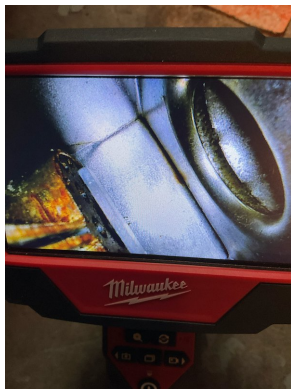
#### Offline Equipment Photos

Top to bottom inspection of the equipment while it is non-operational

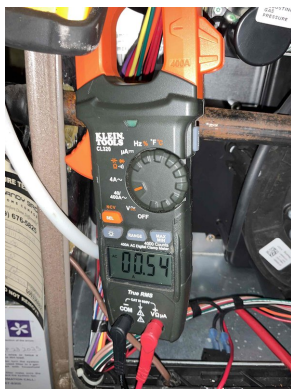
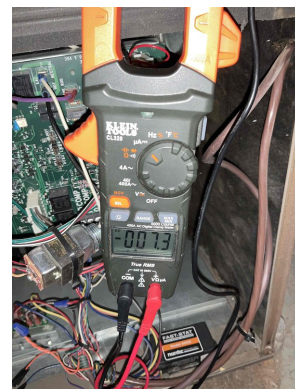
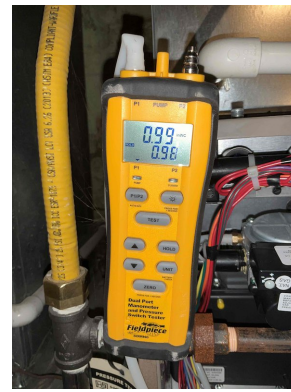
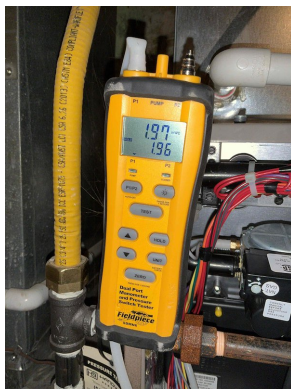
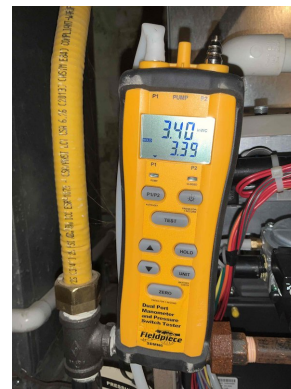
## Online Equipment Testing Photos

Top to bottom inspection photos of the equipment while it is operational. This shows operational readings of the equipment to verify proper range of operation
